**CWA COMPLIANCE EVALUATION INSPECTION REPORT
U.S. ENVIRONMENTAL PROTECTION AGENCY, REGION 5**

Meadowlark Dairy, LLC

NPDES Permit Number: WI-0061905-04-0

Date of Inspection: November 21, 2019

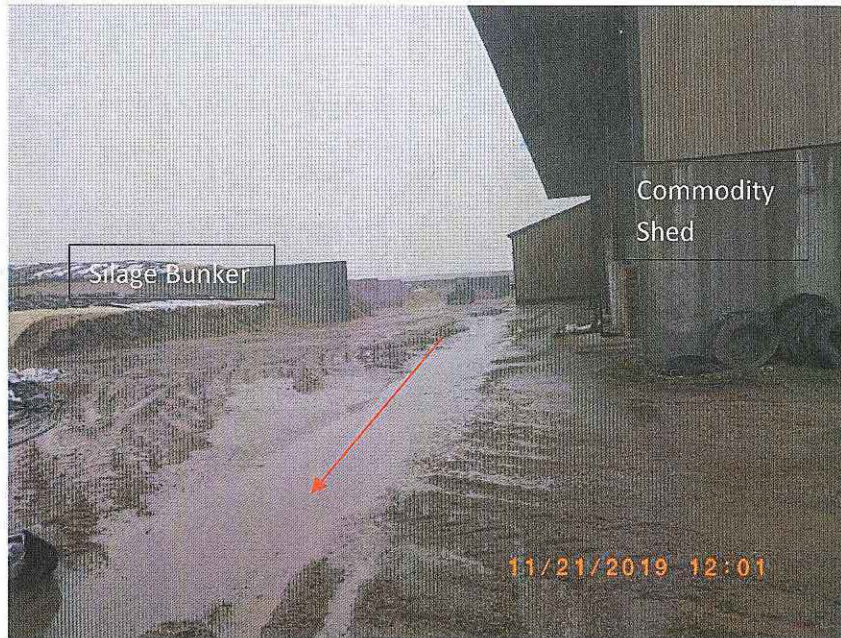
2: IMGP0002

Description: The Process Wastewater Channel between the Silage Bunkers and the Commodity Shed conveys leachate and process wastewater flow by gravity to the Collection Pit. The red arrow shows the direction of flow of the process wastewater in the Process Wastewater Channel.

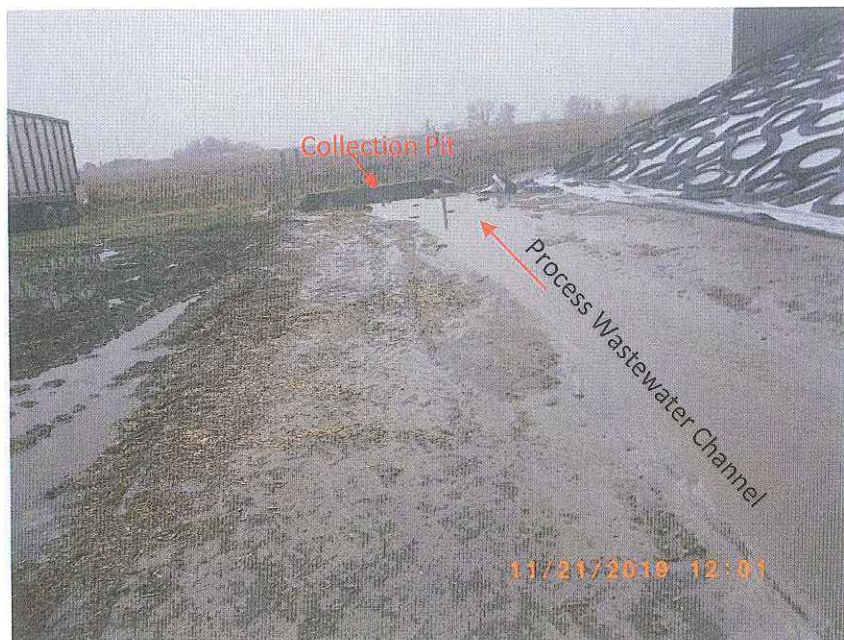
3: IMGP0003

Description: The process wastewater and silage leachate flow by gravity in the Process Wastewater Channel to the west into the Collection Pit. The red arrow shows the direction of flow and identifies the Collection Pit in the photo above.

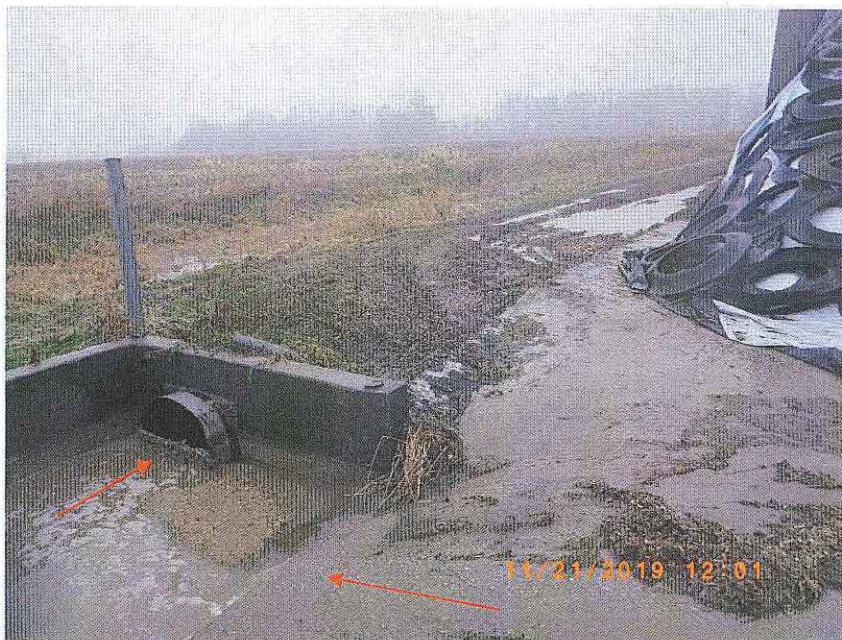
4: IMGP0004

Description: The red arrows show the direction of flow of the process wastewater in the Process Wastewater Channel and into the Collection Pit. The red arrow in the photo in the Collection Pit shows that the process wastewater goes into the culvert inlet which is connected to underground piping that conveys the process wastewater flow by gravity through a culvert outlet into the Concrete Channel south of the Vegetated Treatment Area (VTA).

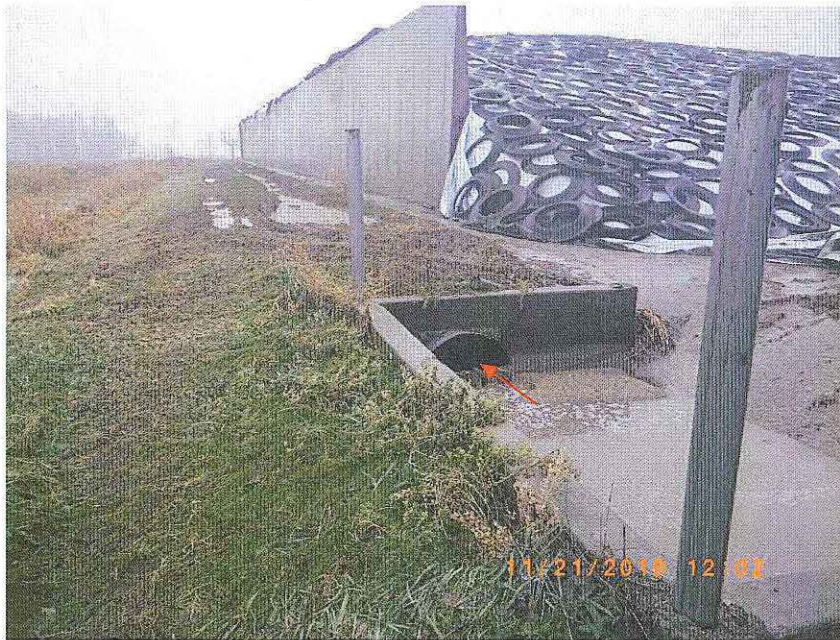
8: IMGP0008

Description: The silage leachate and process wastewater flow west by gravity in the Process Wastewater Channel between the Silage Bunkers and the Commodity Shed into the Collection Pit. The process wastewater within the Collection Pit flows by gravity to north (as shown by the red arrow in the photo) through the culvert inlet into underground piping that conveys the flow by gravity to the north to the Concrete Channel south of the VTA. The underground piping is located on the west side of the Silage Bunkers.

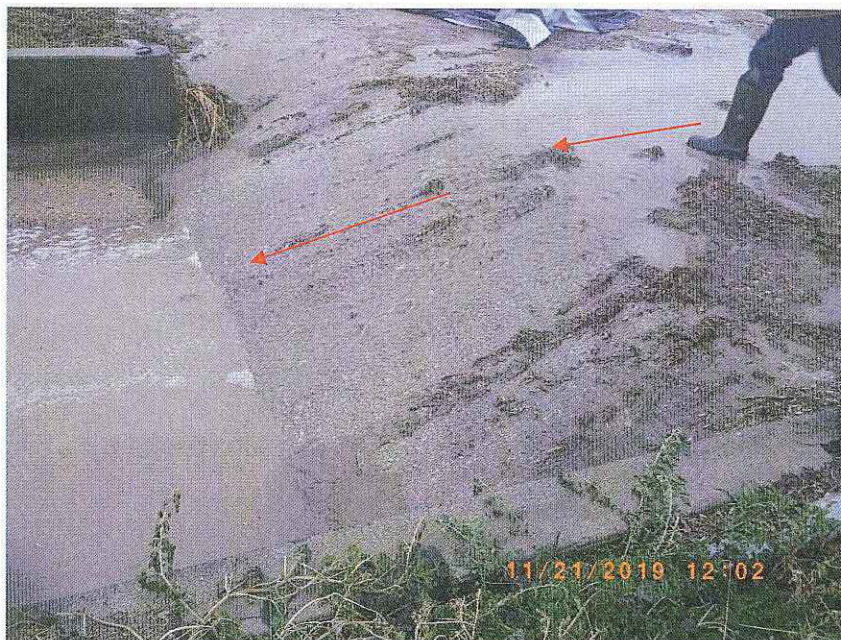
10: IMGP0010

Description: The process wastewater flows in the Process Wastewater Channel to the west into the Collection Pit located on the North Site. The red arrows show the direction of flow into the Collection Pit.

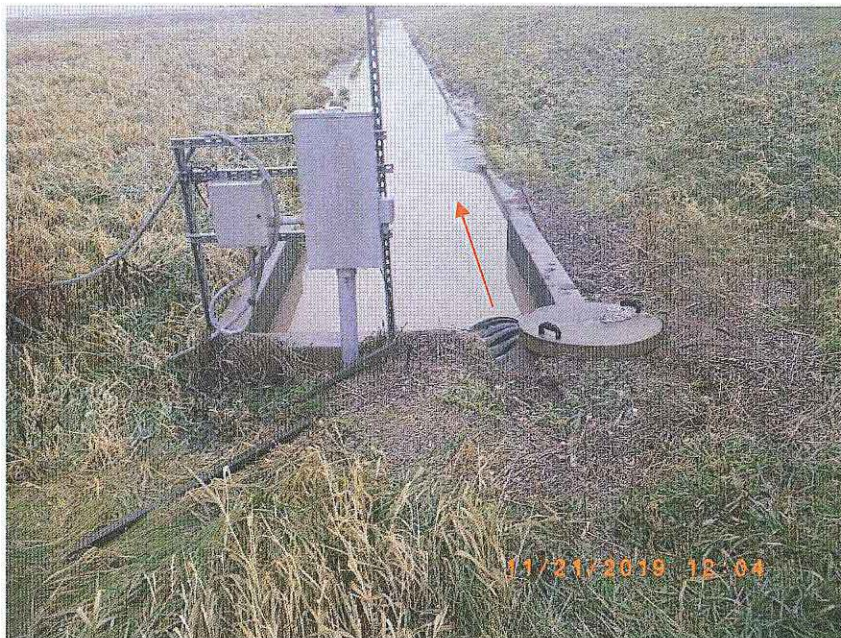
12: IMGP0012

Description: The process wastewater within the Collection Pit flows through the culvert inlet connected to underground piping where process wastewater flows by gravity to the north through a culvert outlet into the Concrete Channel south of the VTA.

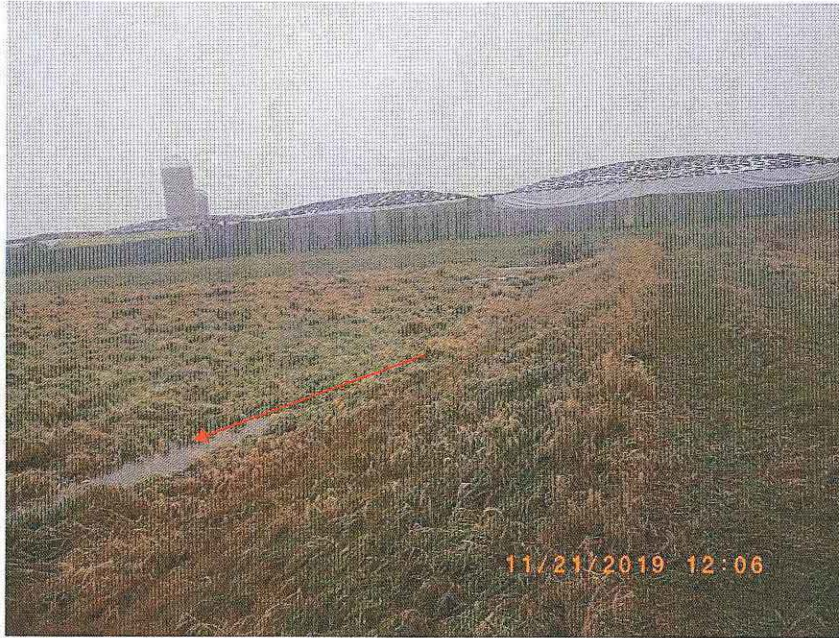
14: IMGP0014

Description: The remaining process wastewater gravity flows through the VTA. At the time of the inspection, EPA observed a channel on the west side of the VTA between the 1st and 2nd spreader bars. The red arrow shows the location of the channel formed within the VTA in the photo above and the direction of flow of process wastewater within the VTA.

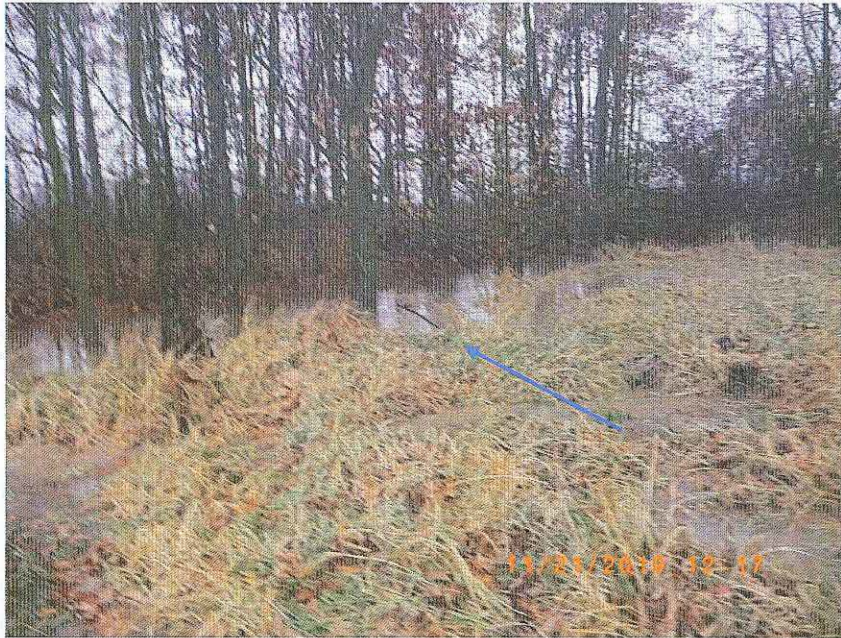
18: IMGP0018

Description: The West Stormwater Ditch was flowing into the unnamed tributary of the Fox River during the inspection. The blue arrow in the photo above shows the direction of flow of the stormwater from the West Stormwater Ditch.

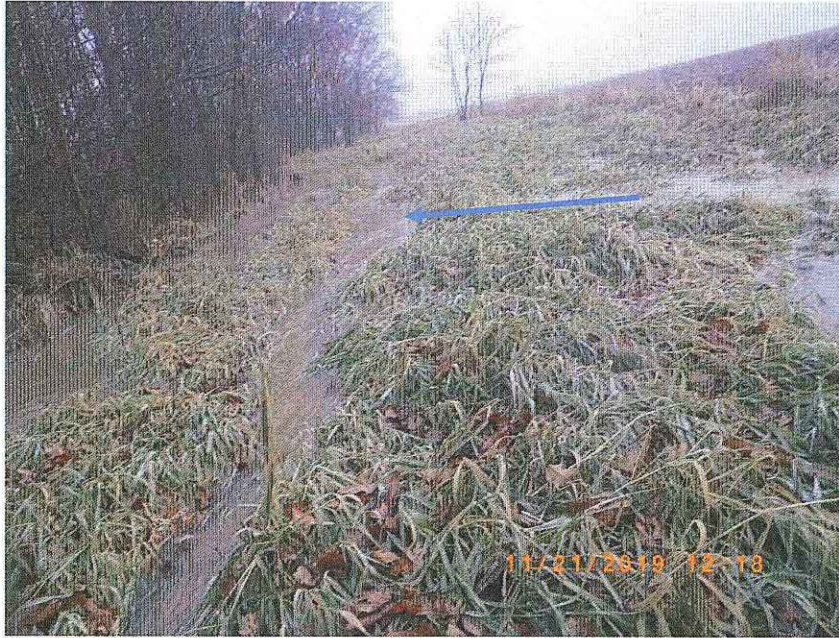
22: IMGP0022

Description: The blue arrow shows the West Stormwater Ditch flowing into the unnamed tributary of the Fox River.

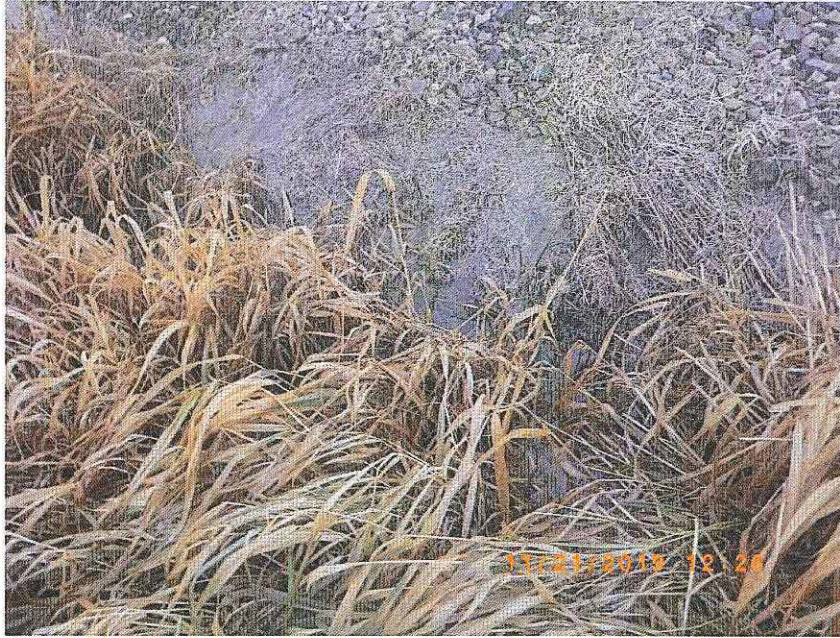
26: IMGP0026

Description: The 4th spreader bar within the VTA, with water seeping from the south side of the spreader bar to the north side.

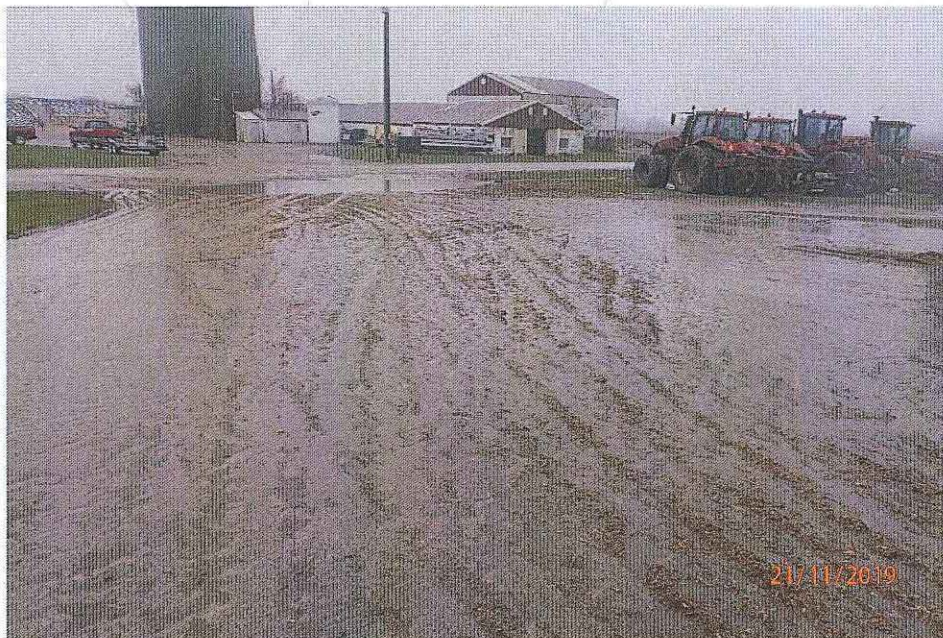
41: PB210003

Description: Used feed, bedding, and manure tracked out of the Large Freestall Barn.

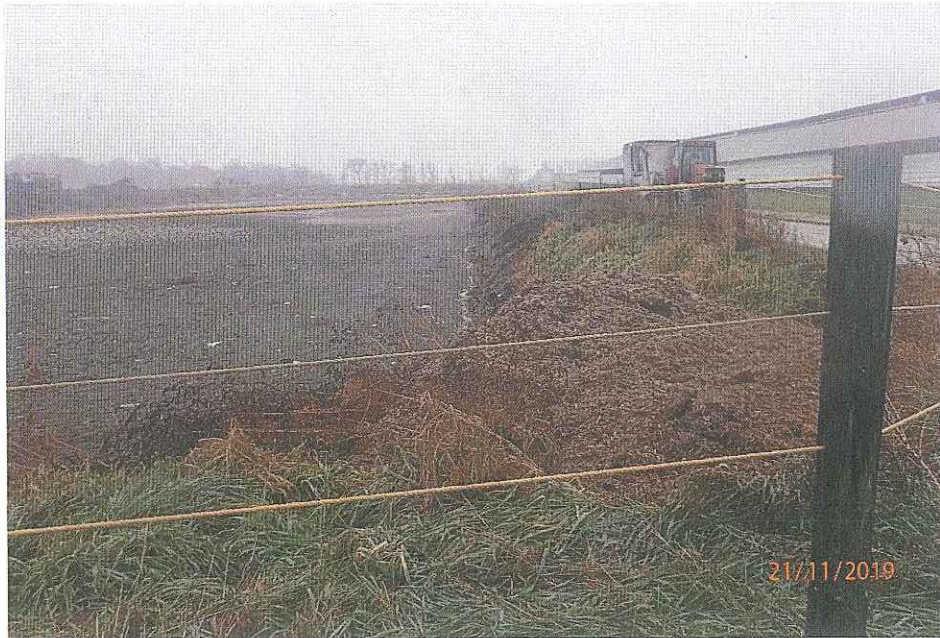
42: PB210004

EPA and Ex. 6. (Personal Privacy) walked to the northwest corner of Pit 1, where EPA observed used bedding and feed dumped on the inner edge of the northwest corner of Pit 1 (photograph PB210004). EPA and Ex. 6. (Personal Privacy) Ex. 6. (Personal Privacy) continued to walk north along the west side of Pit 1. Ex. 6. (Personal Privacy) Ex. 6. (Personal Privacy) explained that the manure, wastewater, and used bedding is scraped into a center transfer pit in the Large Freestall Barn and flows by gravity to Pit 1 (photograph PB210005). EPA observed the Emergency Level marker and the MOL marker installed in Pit 1 (photograph PB210006). EPA continued to walk south along the west side of Pit 1. EPA photographed that the inner berm has not been mowed or maintained (PB210007).

Description: Used bedding, feed, and manure on the inner berm of Pit 1.

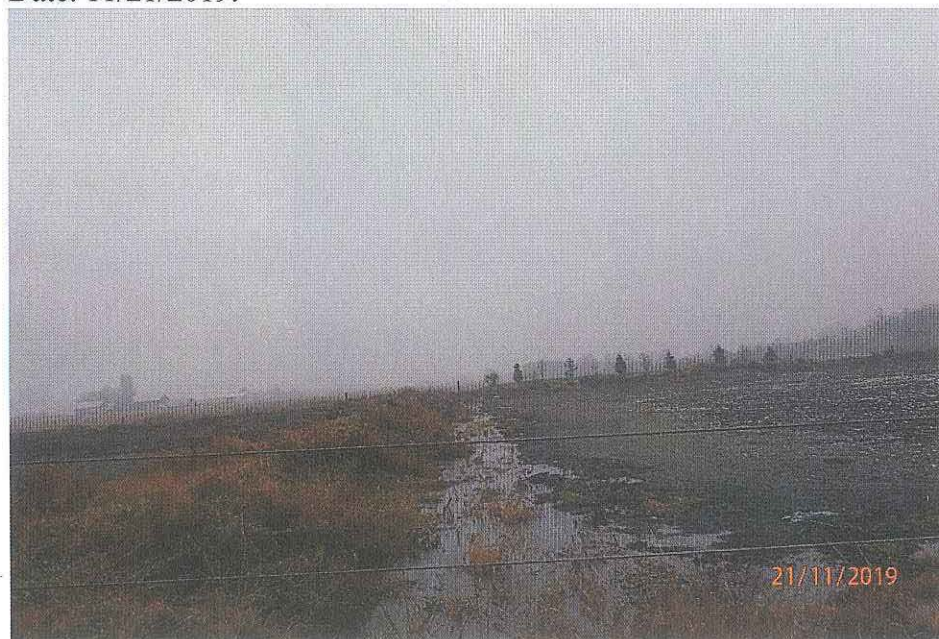
45: PB210007

The berm between Pit 1 and Pit 4 is heavily vegetated (photograph PB210005, PB210007, PB210011). EPA and Ex. 6. (Personal Privacy) Ex. 6. (Personal Privacy) continued to walk south on the west side of Pit 4 and observed the Emergency Level marker (rebar) along with the Maximum Operating Level (MOL) marker, the white marker in photograph PB210009. EPA and Ex. 6. (Personal Privacy) Ex. 6. (Personal Privacy) observed that the manure level in Pit 4 was reaching the MOL. (photograph PB210009). EPA and Ex. 6. (Personal Privacy) Ex. 6. (Personal Privacy) continued to walk along the south side of Pit 4 to the east. EPA and Ex. 6. (Personal Privacy) Ex. 6. (Personal Privacy) observed on the southeast corner of Pit 4 that there was a matted path leading into Pit 4. EPA asked Ex. 6. (Personal Privacy) Ex. 6. (Personal Privacy) if stormwater was flowing into Pit 4, which could compromise its storage

Description: The berm between Pit 1 and Pit 4.

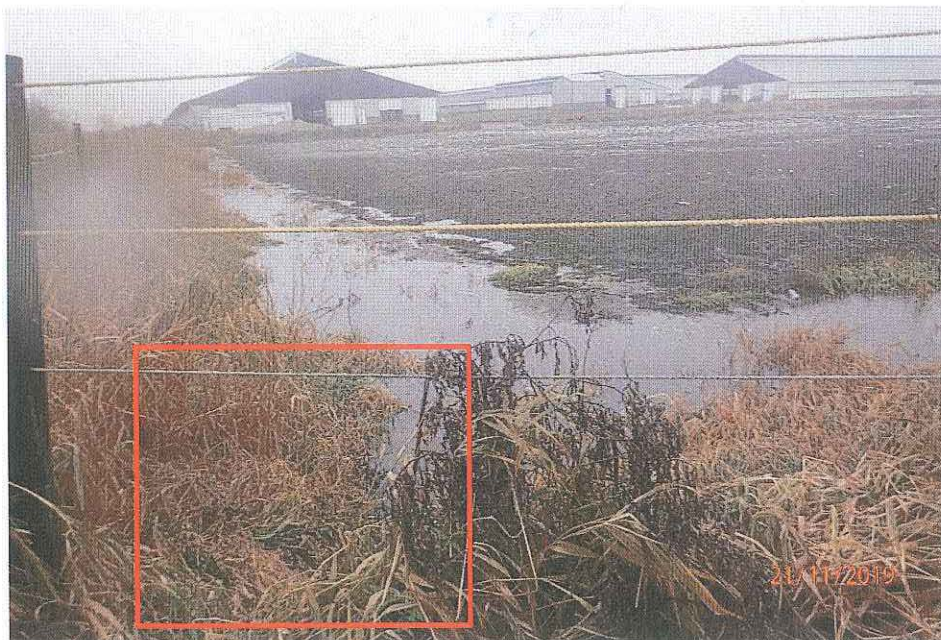
48: PB210010

3. Pit 4 was close to the MOL.
4. Pit 4 may have run-on occurring, which would limit the capacity of Pit 4.
5. In Pit 1, the berm may have erosional issues from solids removal.

Description: Southeast corner of Pit 4. EPA observed that the grass was matted down in the southeast corner of Pit 4 (in the red box in the photo above).

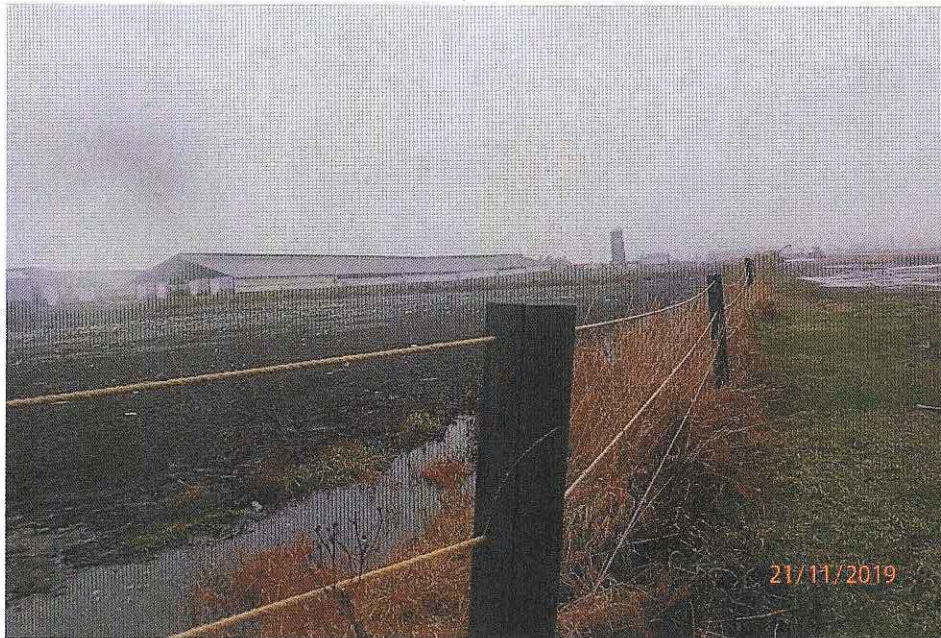
49: PB210011

Description: Overall photo of Pit 4 with inner berm vegetation and the high level within Pit 4.

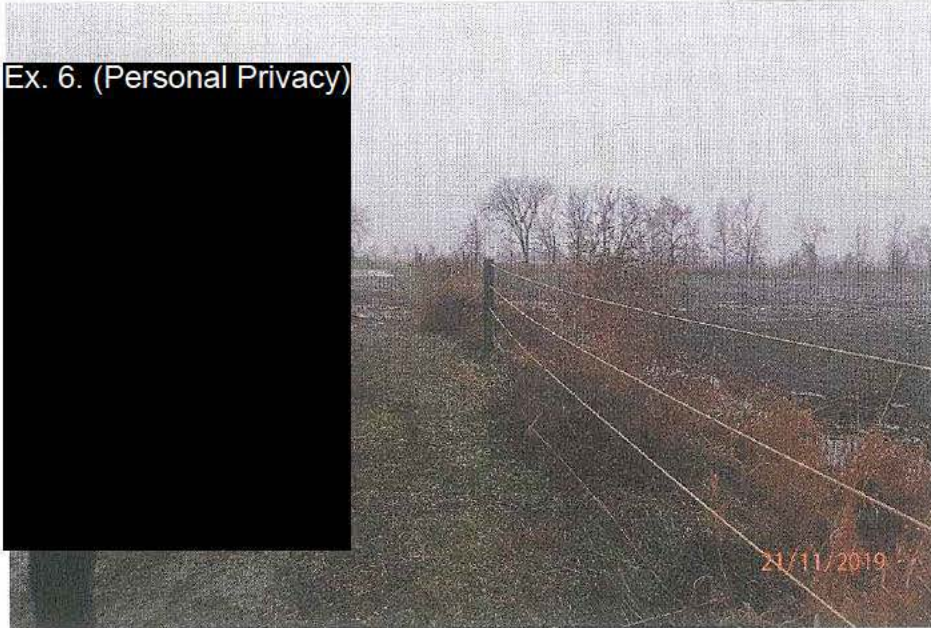
51: PB210013

EPA and **Ex. 6. (Personal Privacy)** began to walk the west side of Pit 4 and Pit 1 to the north. EPA again observed the vegetation growing on the inner berm of Pit 4 and Pit 1 (photographs PB210013 through PB210014). EPA and **Ex. 6. (Personal Privacy)** observed the concrete slab on the east side of Pit 1. The solids are pulled from or scraped into Pit 1 from this pad. EPA asked **Ex. 6. (Personal Privacy)** if the berm of Pit 1 was being damaged from the removal of the solids, but he did not think there was a problem with the berm in Pit 1 (PB210017-PB210020). **Ex. 6. (Personal Privacy)** stated that it was just the solids that had been pushed off the pad and no erosion or berm damage was occurring.

Description: The vegetation on the inner berm and observing the level within Pit 4.

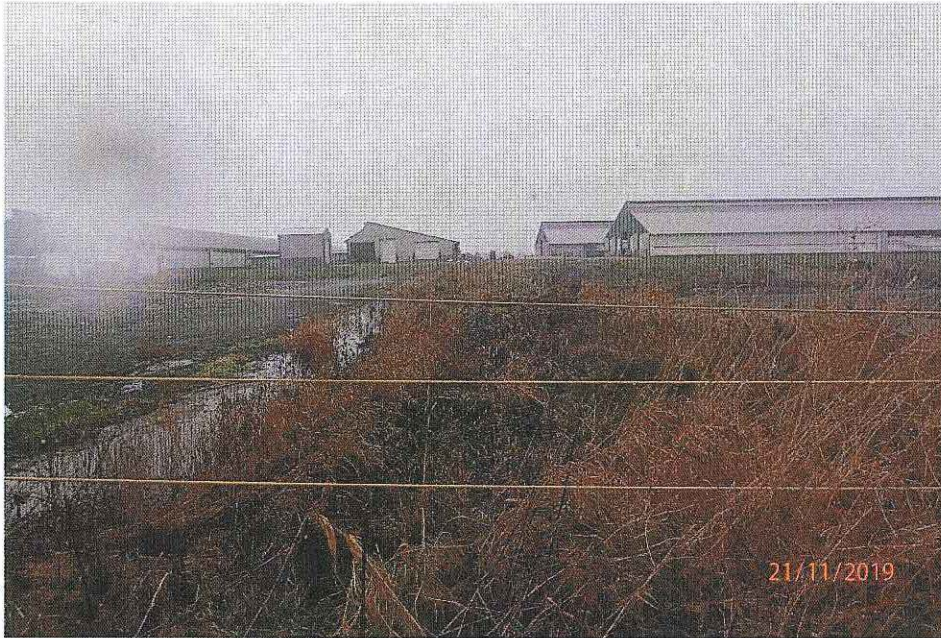
52: PB210014

Description: The berm between Pit 1 and Pit 4 and the amount of vegetation on the berm.

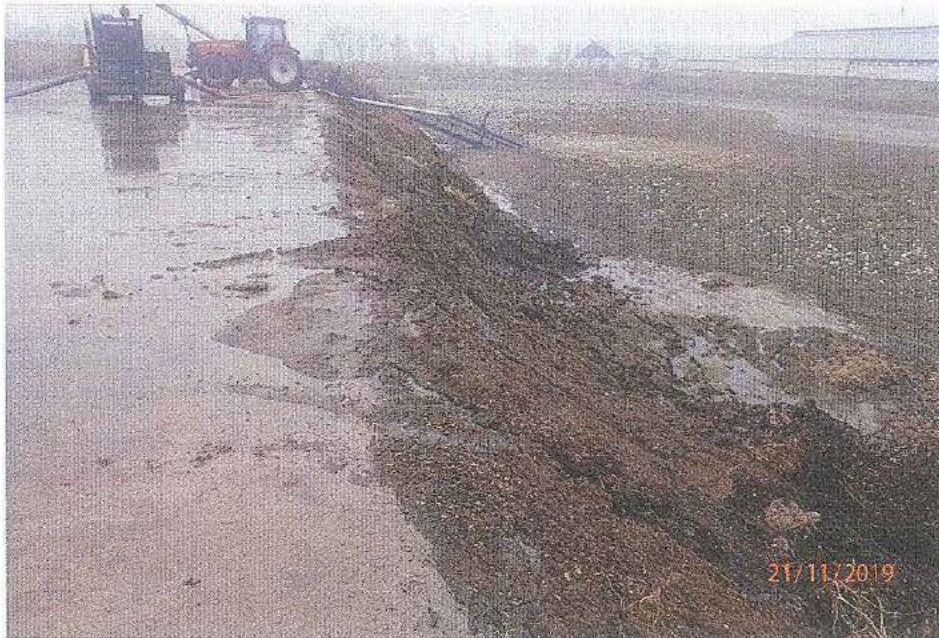
58: PB210020

Description: EPA was looking at the channels within the solids. EPA was concerned if the berm integrity was being compromised.

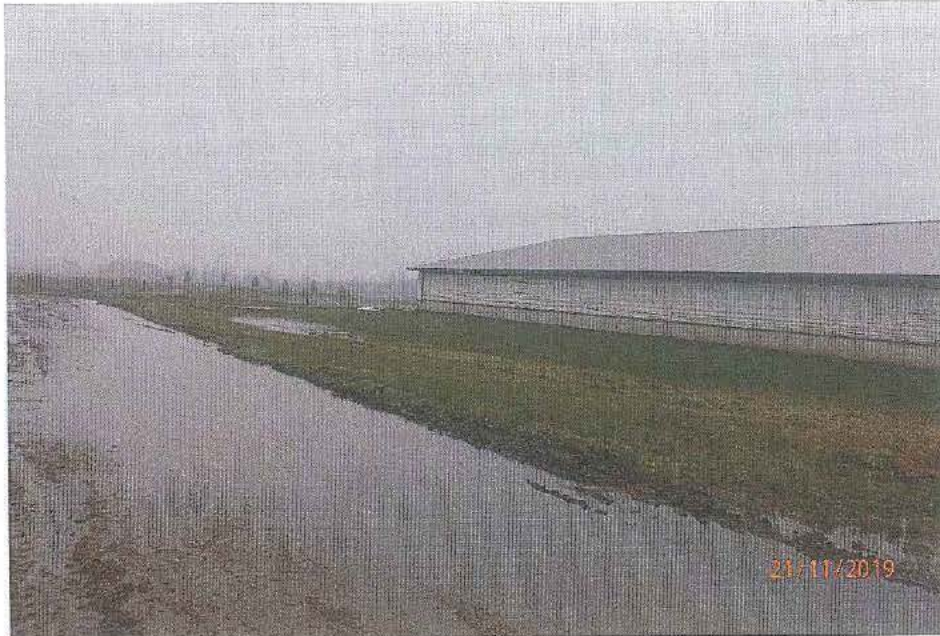
61: PB210023

Description: Stormwater coming into contact used feed, manure, and bedding on the concrete apron on the south side of the Large Freestall Barn.

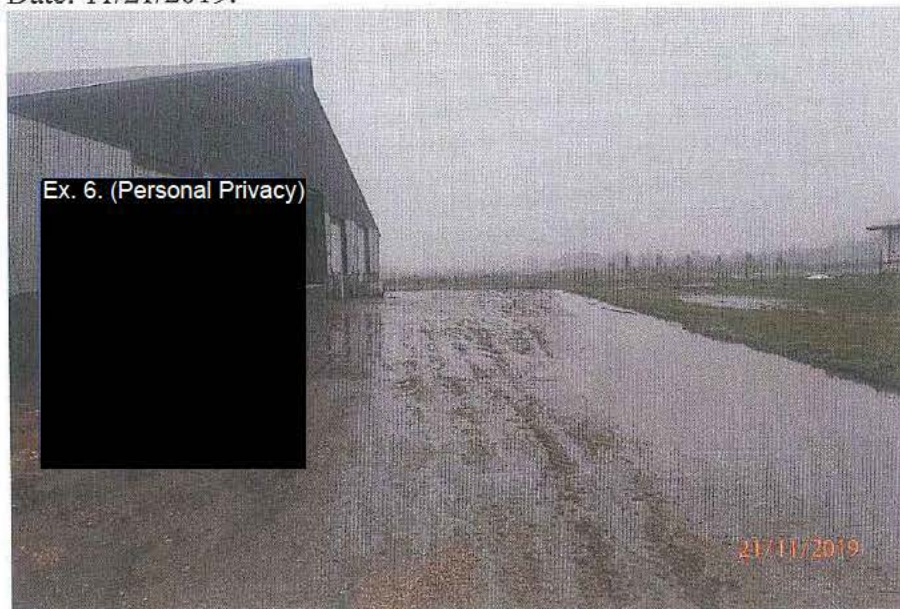
62: PB210024

On the south side of the Large Freestall Barn, EPA observed track-in/track-out from the both the Large and Small Freestall Barns. The track-out of the Small and Large Freestall Barns was mixing with the stormwater during the inspection. EPA did not observe the process wastewater on the south side of the Large and Small Freestall Barns flowing off of the concrete apron and mixing with the clean stormwater in the ditches to the south and east of the Large Freestall Barn (PB210024).

Description: On the concrete apron, track-in/track-out of used bedding, feed, and manure out of the Large and Small Freestall Barns.

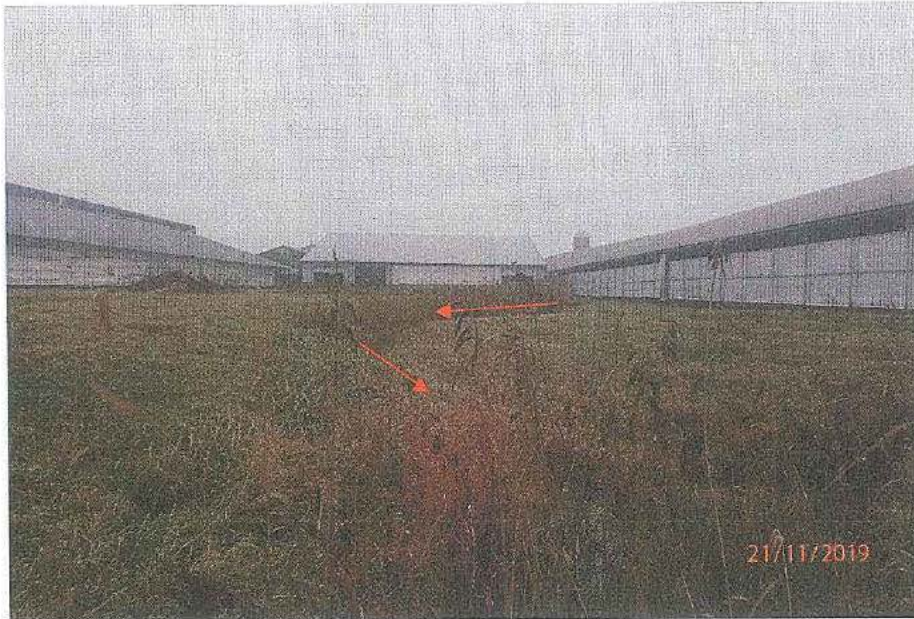
64: PB210026

Description: EPA observed a channel between the Large and Small Freestall Barns that was conveying flow toward the culvert inlet in the photo above. The red arrows show the location of the channel and the direction of flow.

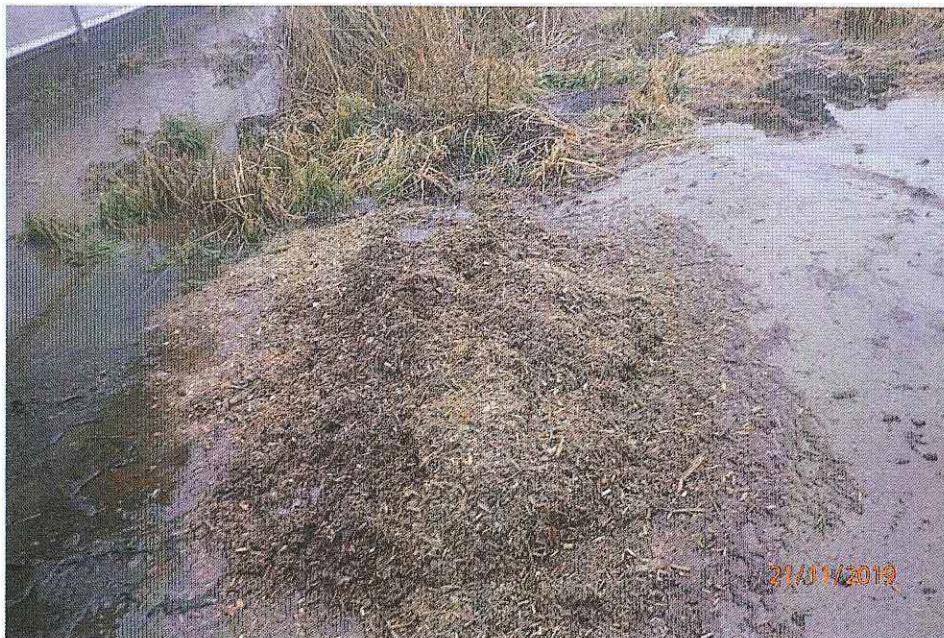
65: PB210027

Description: Used feed, manure, and bedding pushed out of the southeast side of the Small Freestall Barn has been converted to bedpack. Stormwater was coming into contact with the used feed, manure and bedding and flowing off of the concrete apron into the vegetated area between the Small and Large Freestall Barns. The stormwater within the vegetated area flows into culvert inlet between the Large and Small Freestall Barn and flows through a culvert outlet into the West Stormwater Ditch.

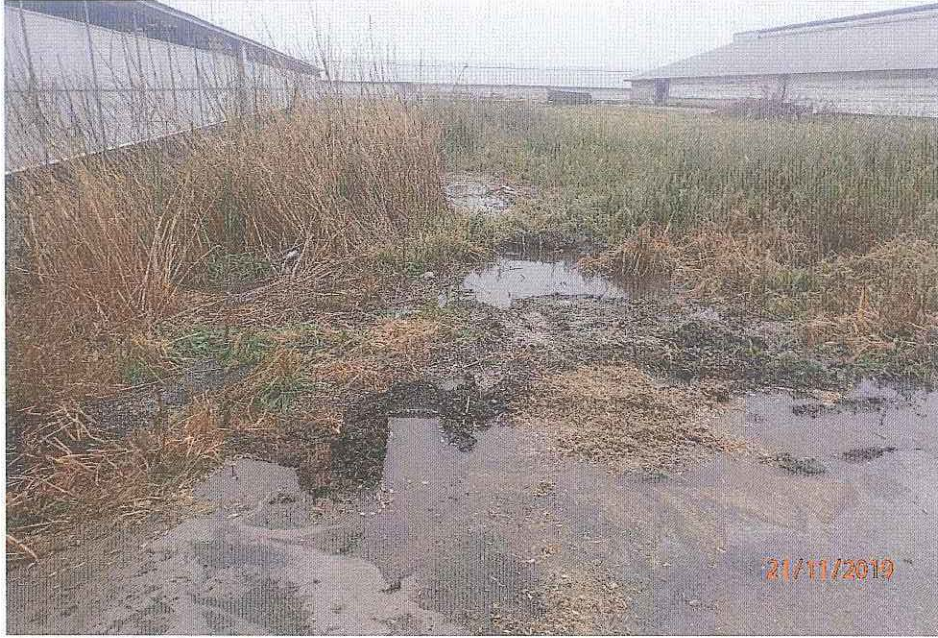
66: PB210028

Description: Used feed, manure, and bedding pushed out of the southeast side of the Small Freestall Barn that has been converted to bedpack. Stormwater was coming into contact with the used feed, manure and bedding and flowing off of the concrete apron into the vegetated area between the Small and Large Freestall Barns. The stormwater within the vegetated area flows into culvert inlet between the Large and Small Freestall Barn and flows through a culvert outlet into the West Stormwater Ditch.

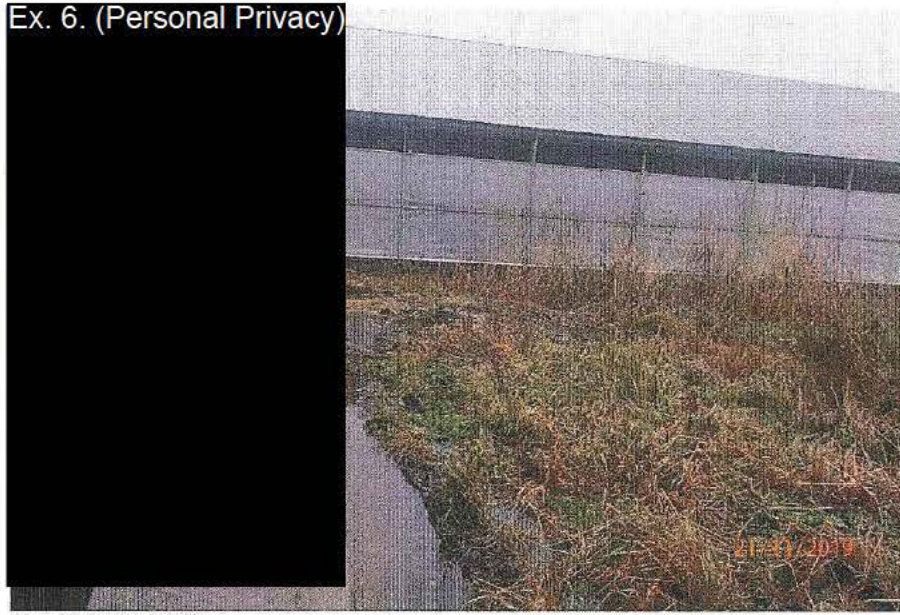
67: PB210029

Description: On the concrete apron south of the Bedpack Barn, EPA observed stormwater coming into contact with used feed, manure, and bedding and flowing off of the concrete apron into the vegeated area between the Large and Small Freestall Barns (as identified by the aerial, Photo Attachment B).

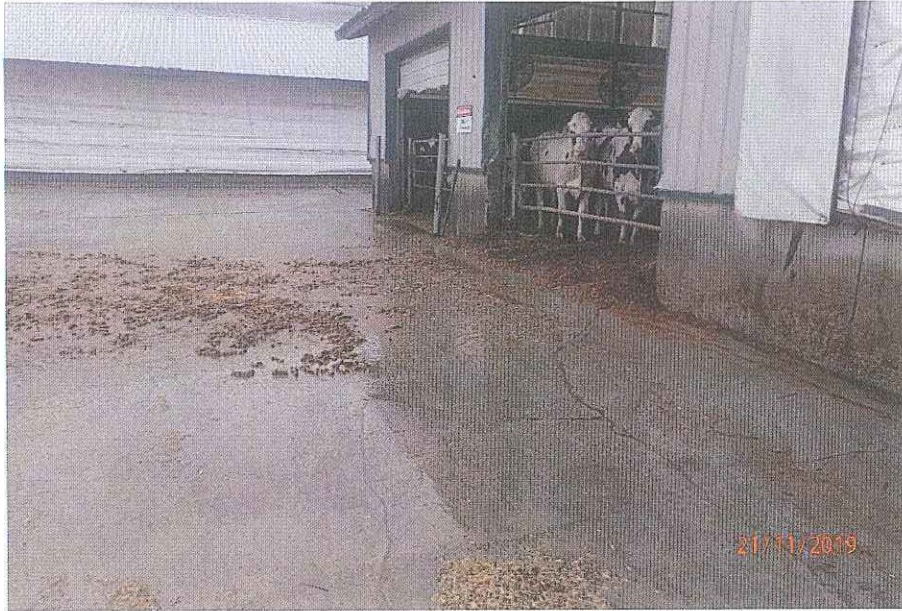
68: PB210030

Description: Used bedding, feed, and manure was being pushed out of the Bedpack Barn or tracked out by equipment on the concrete apron south of the Bedpack Barn. The concrete apron south of the Bedpack Barn is sloped to the south, so that the process wastewater flows off of the concrete apron into the vegetated area between the Small and Large Freestall Barns. EPA observed flow in the vegetated area between the barns flowing toward the culvert inlet.

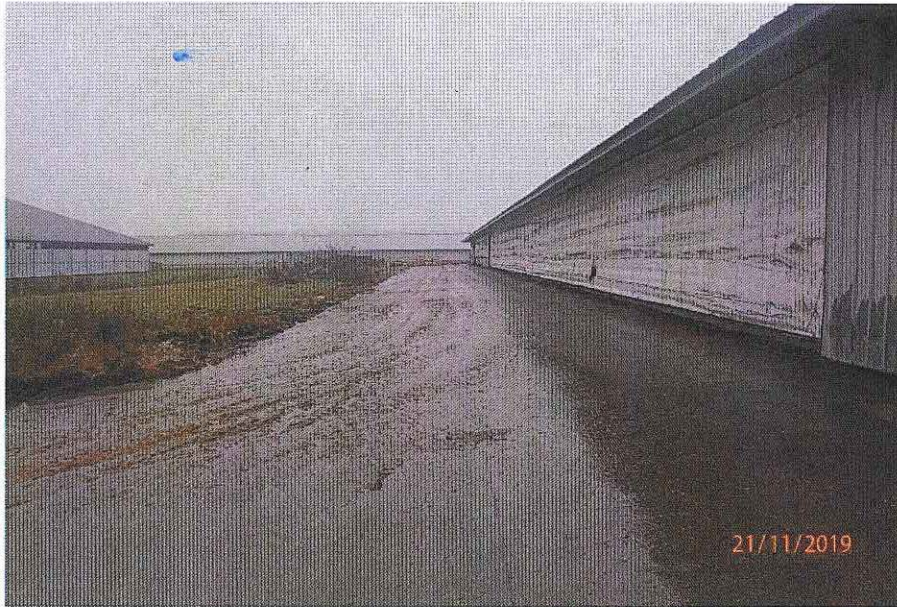
69: PB210031

Description: South side of the Bedpack Barn, where EPA observed used feed, bedding, and manure on and flowing off of the concrete apron into the vegetated area between the barn.

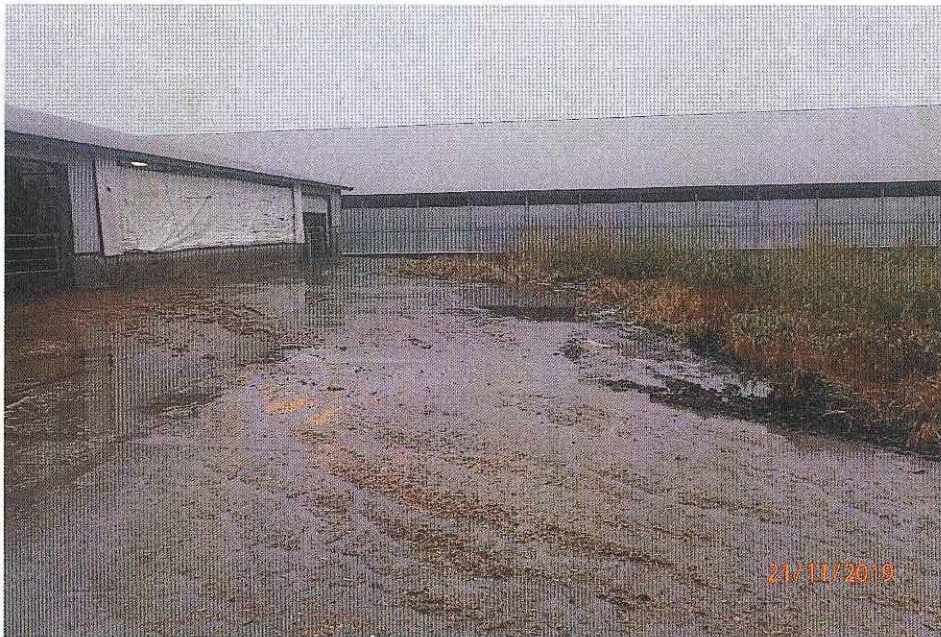
70: PB210032

into the Bedpack Barn. EPA observed stormwater mixed with used feed, bedding, and manure flowing off of the concrete apron into the vegetated area between the Large and Small Freestall Barn. EPA observed a channel conveying flow from the south side of the Bedpack Barn (PB210026) to the culvert inlet between the Large and Small Freestall Barns (PB210032).

Description: Track-in/track-out of used feed, manure, and bedding from the Bedpack Barn mixed with stormwater flowing off of the concrete apron into the vegetated area between the barns.

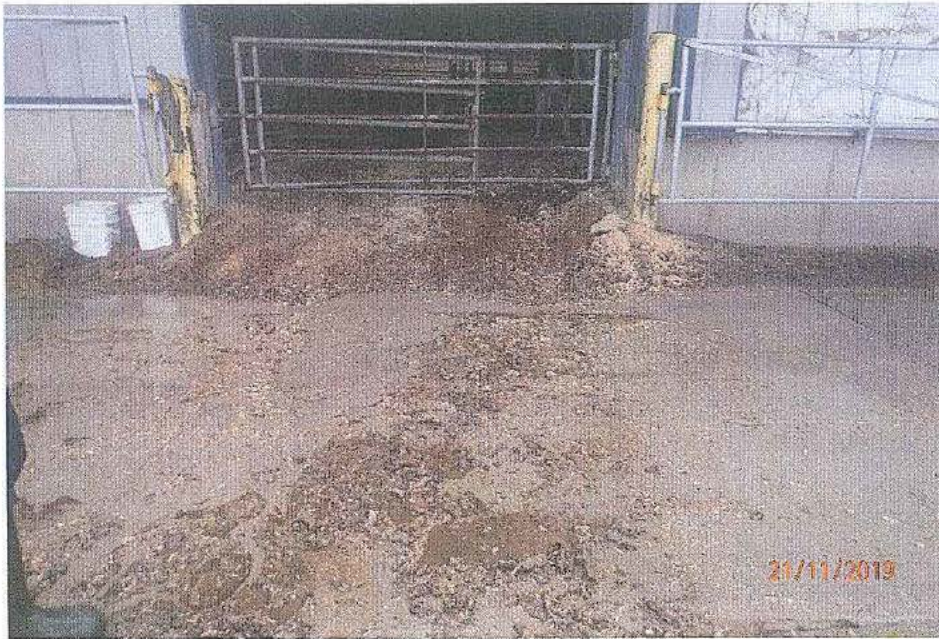
71: PB210033

1. EPA observed track-in/track-out which contained used feed, manure, and used bedding on the concrete apron on the east and south side of the Small Freestall Barn and the Bedpack Barn. EPA observed stormwater coming into contact with track-in/track-out and it was flowing off the concrete apron to the vegetated area between the Large and Small Freestall Barns. EPA observed channeled flow in the vegetated area between the barns flowing toward the culvert inlet between the Small and Large Freestall Barns. The vegetated area is sloped toward the culvert inlet. The culvert inlet is connected to underground piping that conveys flow to a culvert outlet into the West Stormwater Ditch. The West Stormwater Ditch conveys the flow by gravity to the unnamed tributary to the Fox River.

Description: Used feed, manure, and bedding pushed out of the door on the southeast side of the Small Freestall Barn. The stormwater was coming into contact with the used feed, manure and bedding on the concrete apron on the east side of the Small Freestall Barn and flowing off the concrete apron and into the vegetated area between the barns. The vegetated area is sloped toward culvert inlet. The culvert inlet is connected to underground piping that conveys flow to a culver outlet into the West Stormwater Ditch. The West Stormwater Ditch conveys the flow by gravity to the unnamed tributary of the Fox River.

Please provide an explanation by e-mail within 30 calendar days of receipt of this report on how the areas of concern listed above have been or will be addressed.

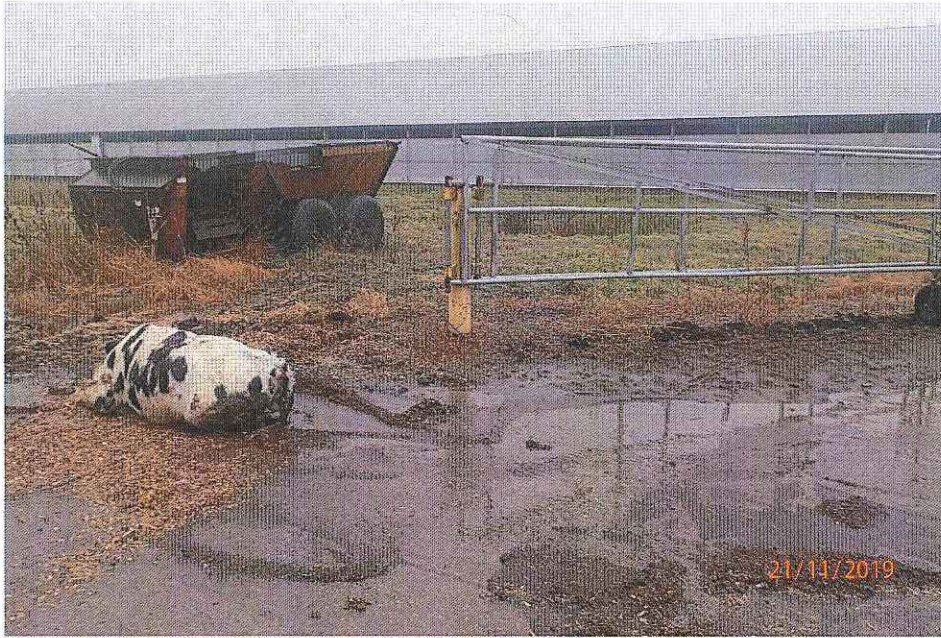
72: PB210034

2. EPA observed a mortality that was being stored on the southeast side of the Small Freestall Barn and at the time of inspection being exposed to stormwater. The stormwater that came into contact with the mortality was observed flowing into the vegetated area between the Small and Large Freestall Barns which flows into the culvert inlet between the Small and Large Freestall Barns.

Description: Dead cow stored on the concrete apron on the southeast corner of Small Freestall Barn. Stormwater was coming into contact with the dead cow, which the concrete is sloped to flow toward the vegetated area toward the culvert inlet between the Large and Small Freestall Barn. The culvert inlet is connected to underground piping that conveys the flow by gravity to the culvert outlet that flows into the West Stormwater Ditch. The West Stormwater Ditch conveys flow by gravity to the unnamed tributary of the Fox River.

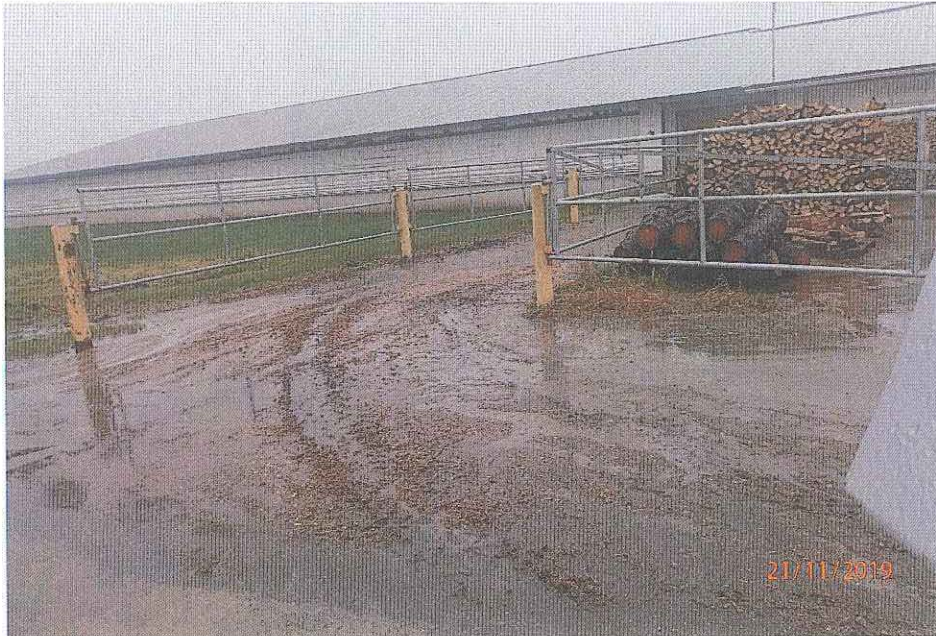
73: PB210035

Description: Used feed, manure, and bedding from track-in/track-out of equipment that goes into the Large and Small Freestall Barns and the Calf Barn.

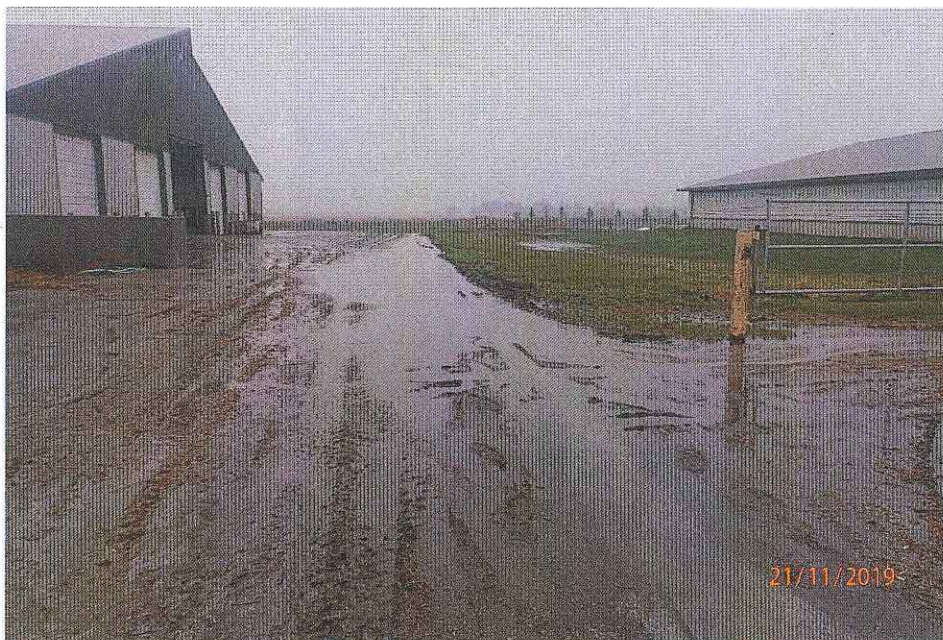
74: PB210036

Description: Track-in/track-out of used feed, manure, and bedding on the concrete apron and also used as a cattle walkway between the Small and Large Freestall Barns and the Calf Barn.

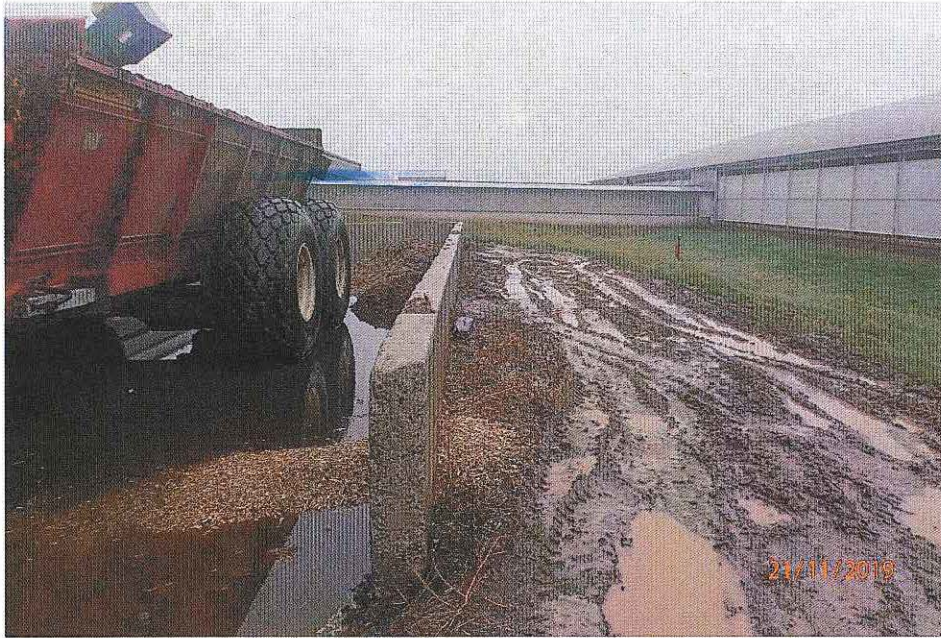
83: PB210045

EPA observed the clean out for the Calf Barn located on the southwest side of the Calf Barn. Some of the feed and wastewater had spilled over the collection area, but EPA did not observe it making it into the culvert between the Calf Barn and Heifer Barn (PB210043-PB210047). EPA and **Ex. 6 (Personal Privacy)** walked to the west around the Heifer Barn, where **Ex. 6. (Personal Privacy)** showed EPA the collection pit for the Heifer Barn. **Ex. 6. (Personal Privacy)** said that the manure within the Heifer Barn is pumped via underground piping into Pit 4 (PB210049). EPA observed track-in/track-out from the west side of the Heifer Barn onto the concrete apron on the west side of the Heifer Barn. The concrete apron and the area south of the concrete apron is sloped to the west toward a ditch. EPA observed a slight berm and heavy vegetation around the ditch. EPA did not observe runoff from the Heifer Barn.

Description: Bedding, feed, and process wastewater spilled over the edge of the pump out area of the Calf Barn.

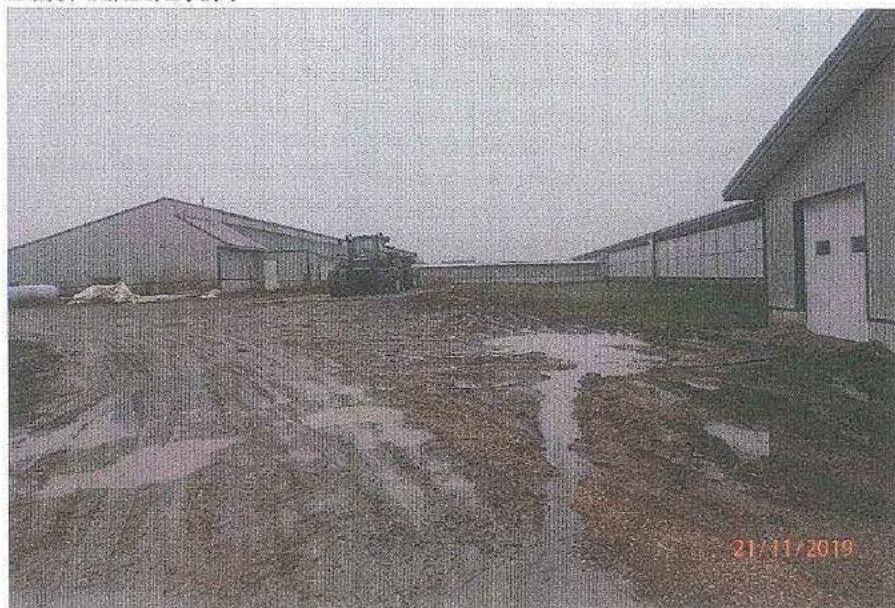
85: PB210047

Description: Track-in/track-out of used feed, manure, and bedding from the Heifer Barn.
